Subject:	Installing a Backup Alarm Silverado EV WT
Models Years Affected:	2024 – Beyond
Models Affected:	Silverado EV WT
Origination Date:	May 20, 2024
Revision Date:	N/A

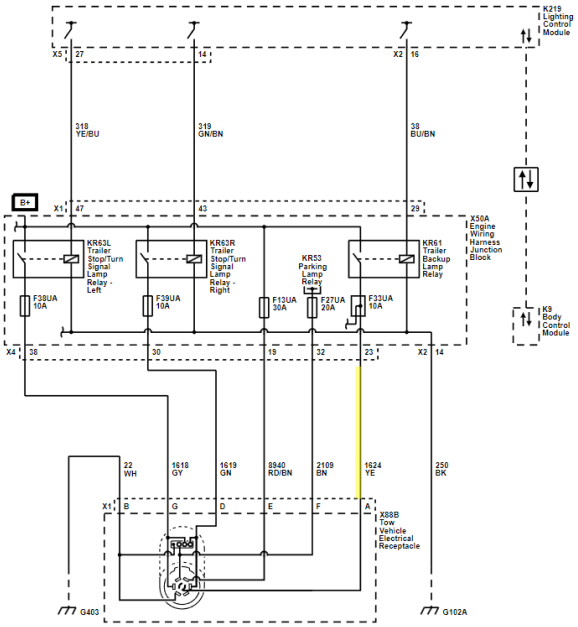
Figure 1

General placement: Under back-driver's side of truck bed

1. The trailer wiring is accessible by removing the close-out panel behind the LR wheel – (see figure 1).
2. Partially remove the harness tape wrapping to expose the wires in the harness – (see figure 2)
3. Insert a Loop back circuit to the backup alarm as shown in Figures 3 and 4 or simply tap into the yellow wire. Be sure to use environmentally seal connections to prevent any corrosion to the wiring.

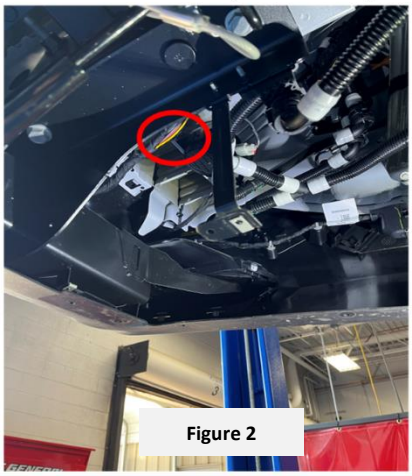
Figure 2

Reverse Signal View: Back driver's side of vehicle. Yellow wire (once visible)
